U.S. Department
of Transportation
**Federal Highway
Administration**

**LTPP Seasonal Monitoring
Program**
Site Monitoring Suspension
Status Report
Section 100102, Ellendale
Delaware

SEASONAL MONITORING PROGRAM SUSPENSION STATUS REPORT DELAWARE SECTION 100102

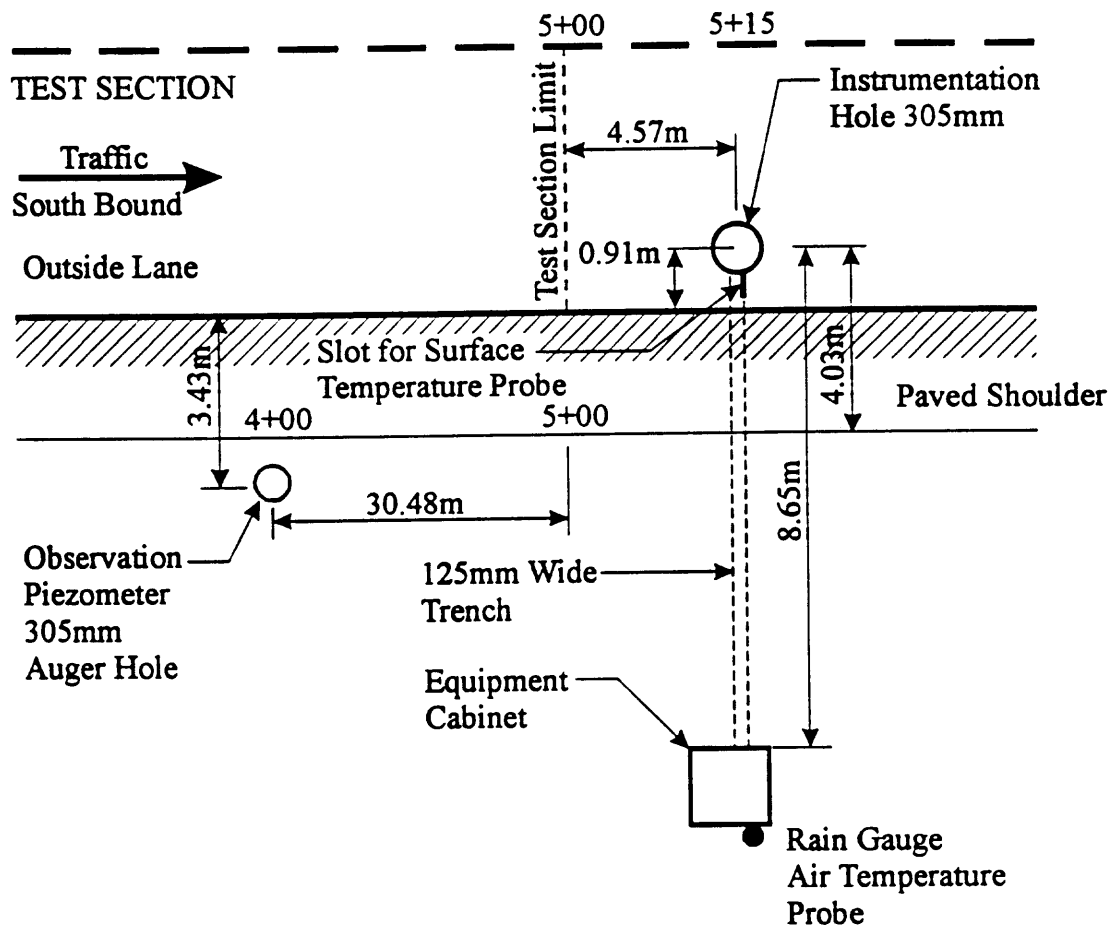
Figure 1. Location of Seasonal Monitoring Instrumentation Installed at SPS 100102

Figure 1 shows the locations of the installed instrumentation at the site. The instrumentation hole is at Station 5+15 and the piezometer is at Station 4+00. Table 4 gives the elevations of test section 100102 before and after the overlay. All offsets are from PK nails found at the outside pavement edge.
